DEPARTMENT OF TRANSPORTATION

Quality Assurance and Source Inspection

Contract #: 04-0120F4Cty: SF/ALA Rte: 80 PM: 13.2/13.9File #: 69.28**WELDING INSPECTION REPORT****Resident Engineer:**Pursell, Gary**Address:** 333 Burma Road**City:** Oakland, CA 94607**Report No:** WIR-012176**Date Inspected:** 10-Feb-2010**Project Name:** SAS Superstructure**OSM Arrival Time:** 645**Prime Contractor:** American Bridge/Fluor Enterprises, a JV**OSM Departure Time:** 1845**Contractor:** Zhenhua Port Machinery Company, Ltd (ZPMC), Changxing Island **Location:** Shanghai, China

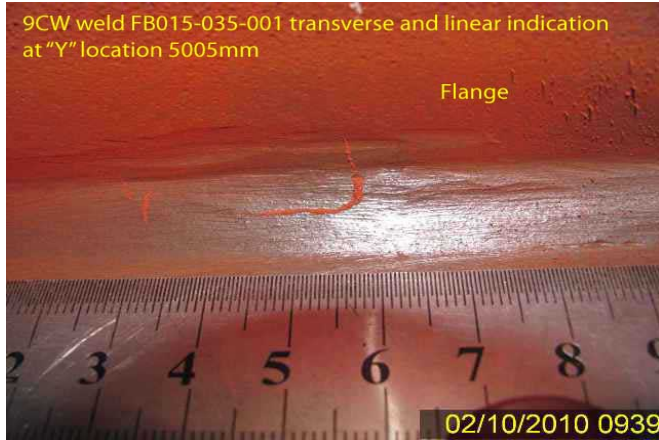
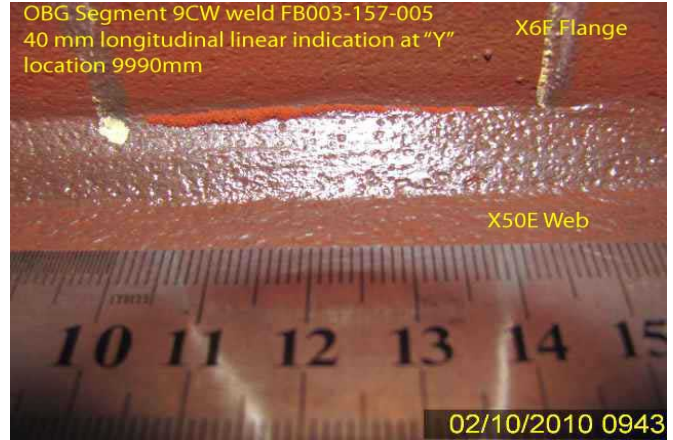
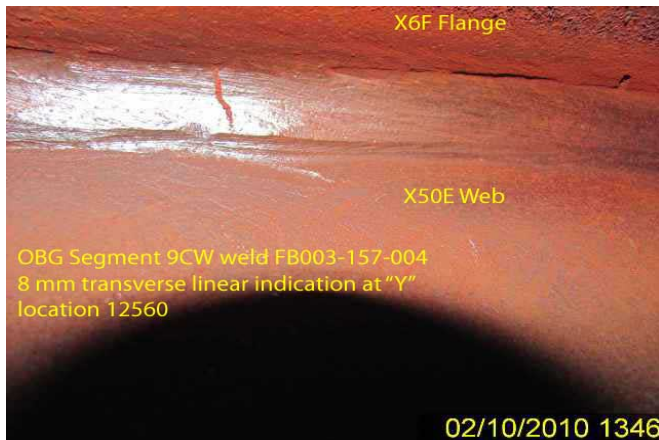
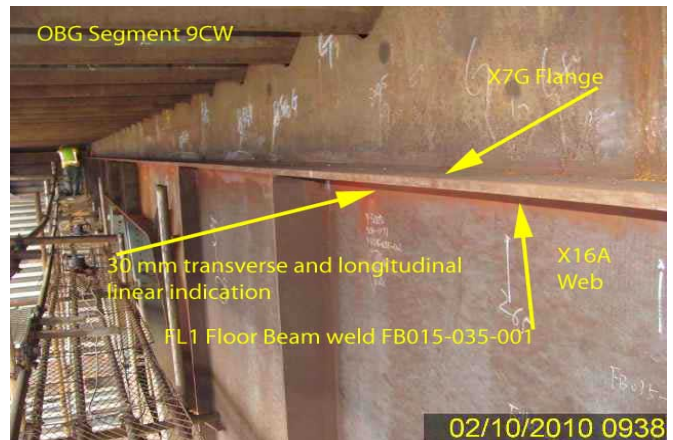
This QA Inspector performed Visual Testing previously tested and accepted by ZPMC for OBG Segment 9CW floor beam web to flange welds at panel point 77. A total of three (3) indications were found during VT. Visual indications were confirmed with Magnetic Particle Testing (MT). An incident report was issued for the above mentioned indications. A MT TL-6028 report was generated this date for additional information. The following welds were tested:

FB015-035-001, 30 mm transverse and longitudinal linear indication at "Y" location 5005.

FB003-157-004, 8 mm transverse linear indication at "Y" location 12560.

FB003-157-005, 40 mm longitudinal linear indication at "Y" location 9990.

See photos below for additional information.
